USAAVLABS TECHNICAL REPORT 68-50B

SMALL GAS TURBINE ENGINE COMPONENT TECHNOLOGY - TURBINE VOLUME II PHASE II SUMMARY REPORT

August 1968

CONTRACT DA 44-177-AMC-182 (T)
CURTISS-WRIGHT CORPORATION
WOOD-RIDGE, NEW JERSEY

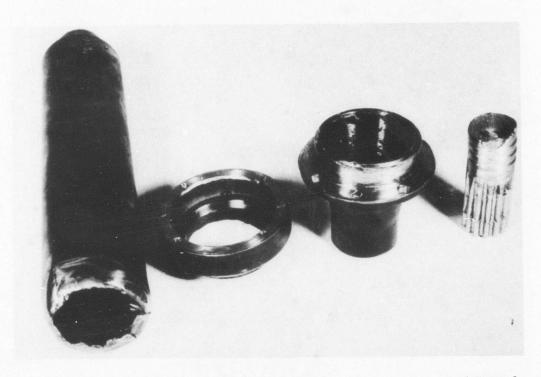
Approx 1 x

A photo showing the locations of fracture in the interconnecting shaft (three LH pieces), and the industrial gearbox shaft spline end fracture aft of the splines (RH piece).
